# **PRE-CERCLIS SITE SCREENING REPORT**

Federated Metals Division Site  
St. Louis, Missouri

August 31, 2006

# MISSOURI SUPERFUND PRE-CERCLIS SITE SCREENING FORM

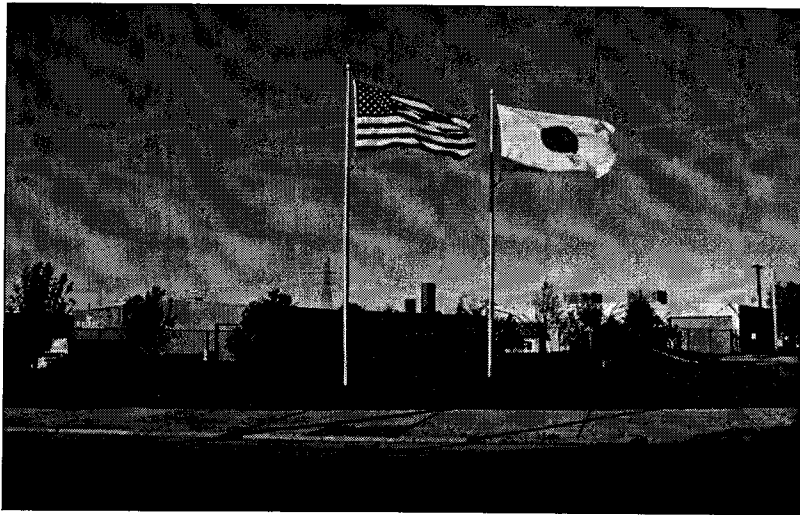
**Photograph 1**

View of neighboring property located in  
Federated Metals Division site area.  
View looking northwest.

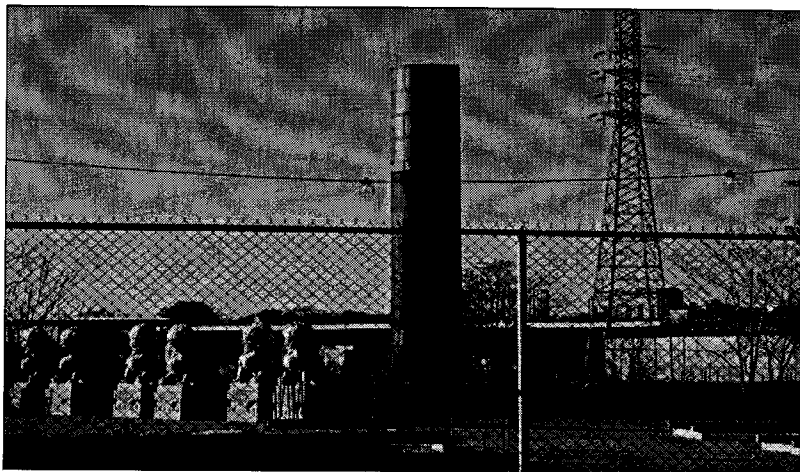
**Photograph 2**

View of a smoke stack on neighboring  
property located in Federated Metals  
Division site area. View looking west.

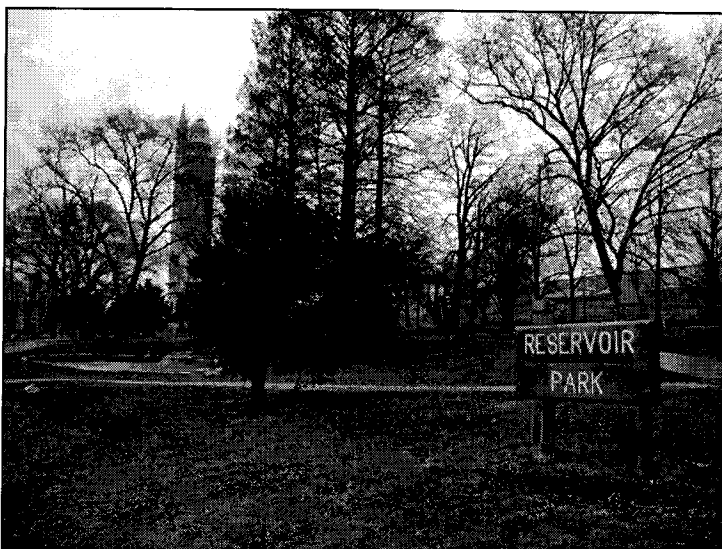
**Photograph 3**

Compton Hill Reservoir Park, view of  
sampling location 1. View facing north  
from corner of Grand Boulevard and Russell  
Boulevard.

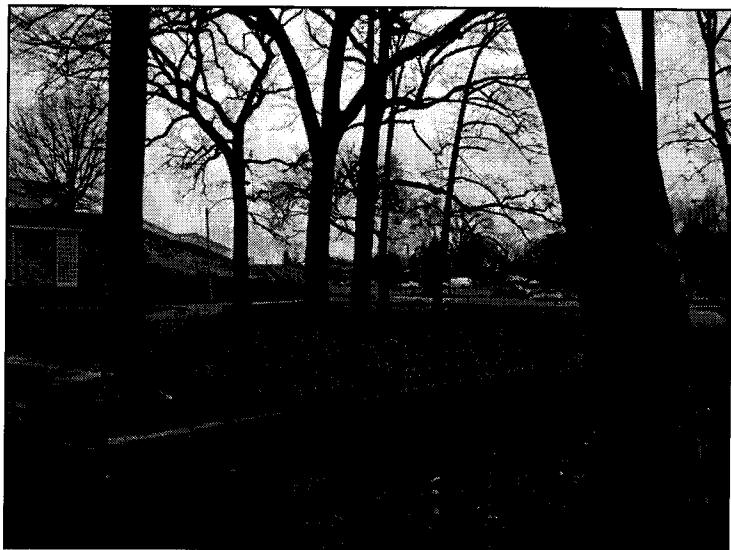
**Photograph 4**

Compton Hill Reservoir Park, view of  
sampling locations 1. View facing north from  
Compton Hill Place.

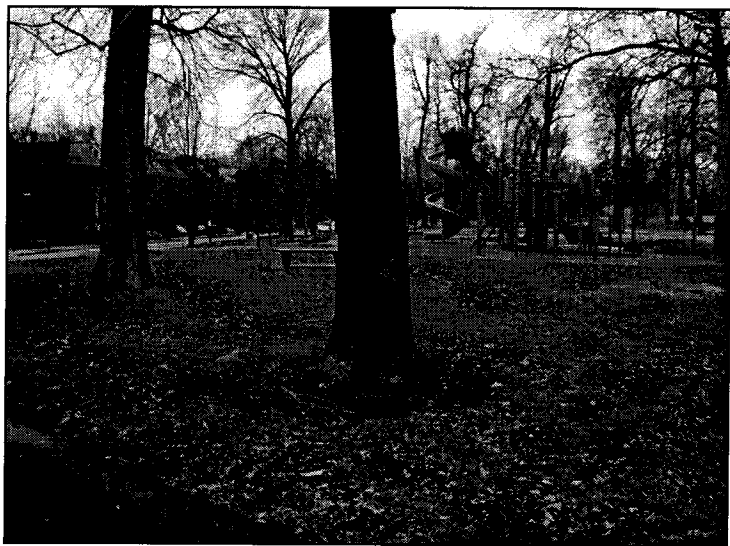
**Photograph 5**

Compton Hill Reservoir Park, view of  
sampling location 1. View facing south  
towards Compton Hill Place.

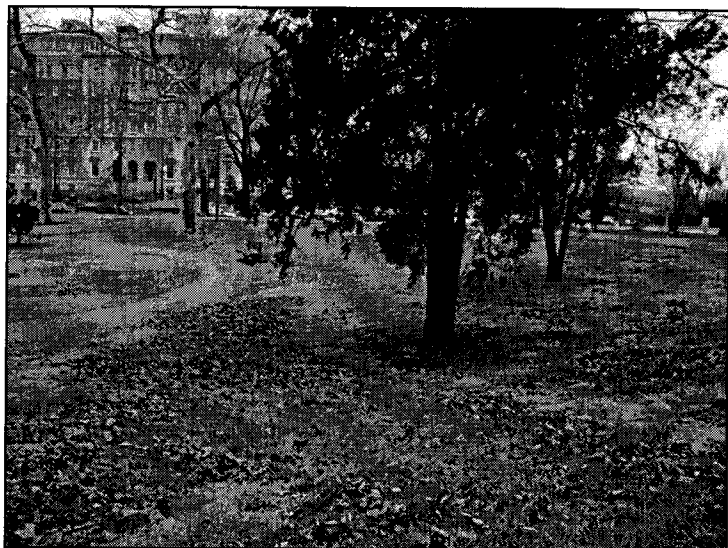
**Photograph 6**

Compton Hill Reservoir Park, view of  
sampling location 1. View facing east towards  
Grand Boulevard.

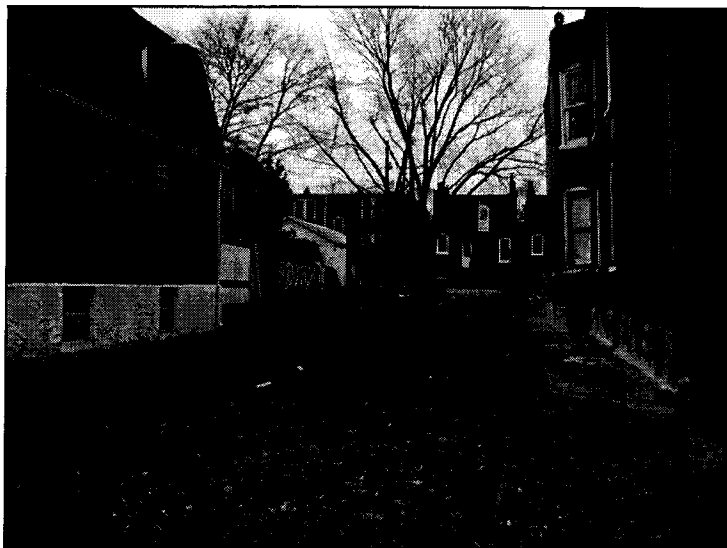
**Photograph 7**

4136 Flad Avenue, view of sampling  
location 2. View facing south from Flad  
Avenue.

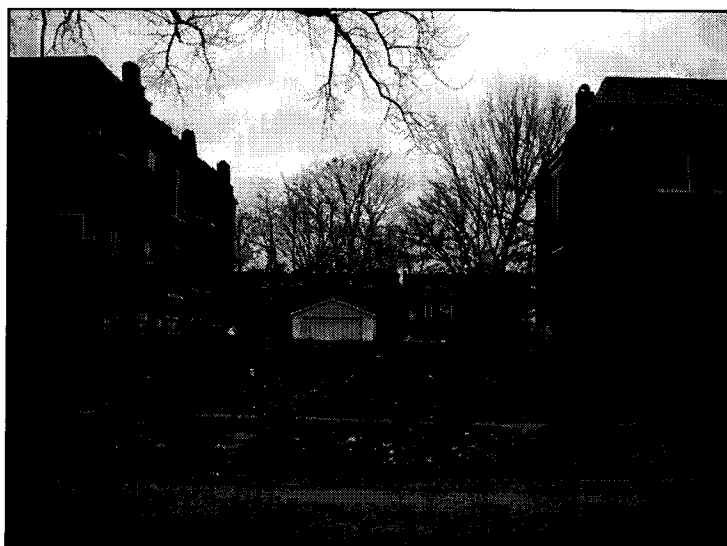
**Photograph 8**

1422 DeTonty Street, view of sampling  
location 3. View facing south from DeTonty  
Avenue.

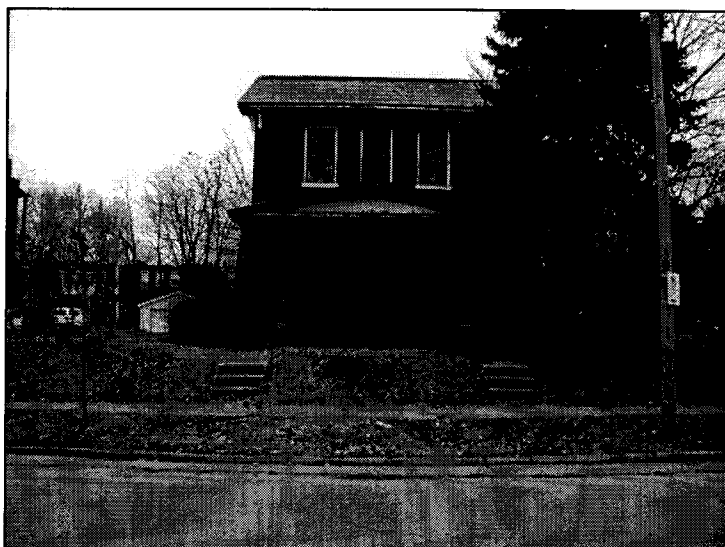
**Photograph 9**

1426 DeTonty Street, view of sampling  
location 4. View facing south from DeTonty  
Avenue.

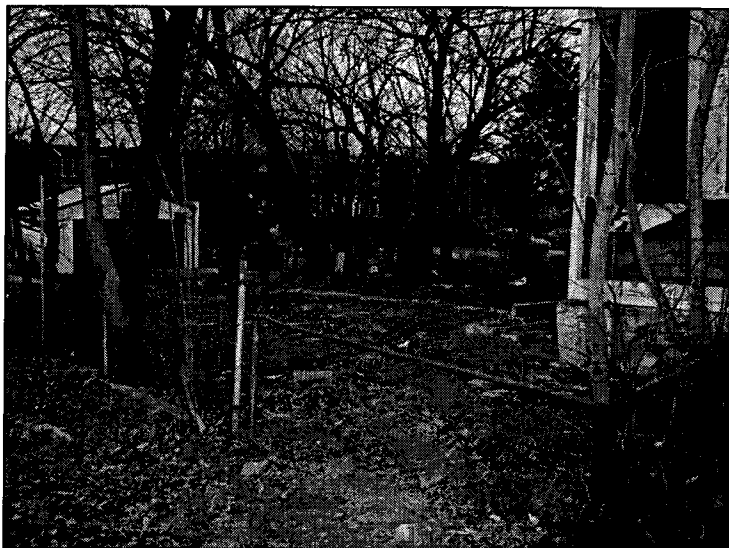
1426 DeTonty Street, view of sampling  
location 4. View facing southwest from  
southeast corner of 1426 DeTonty Steet  
residence.

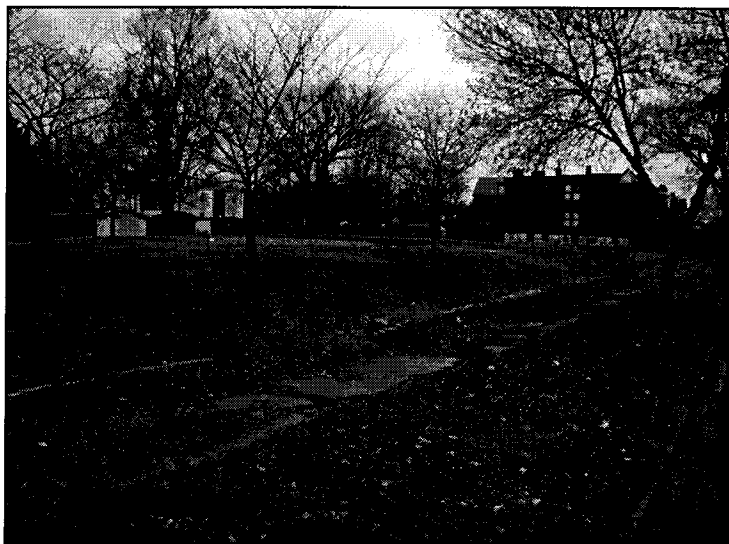
4154-4156 DeTonty Street, view of sampling  
location 5. View facing southwest from  
DeTonty Street.

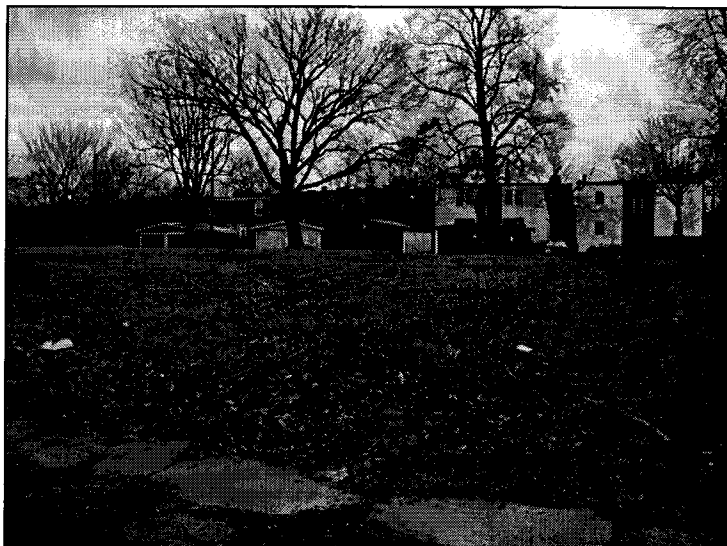
4154-4156 DeTonty Street, view of sampling  
location 5. View facing south from  
DeTonty Street.

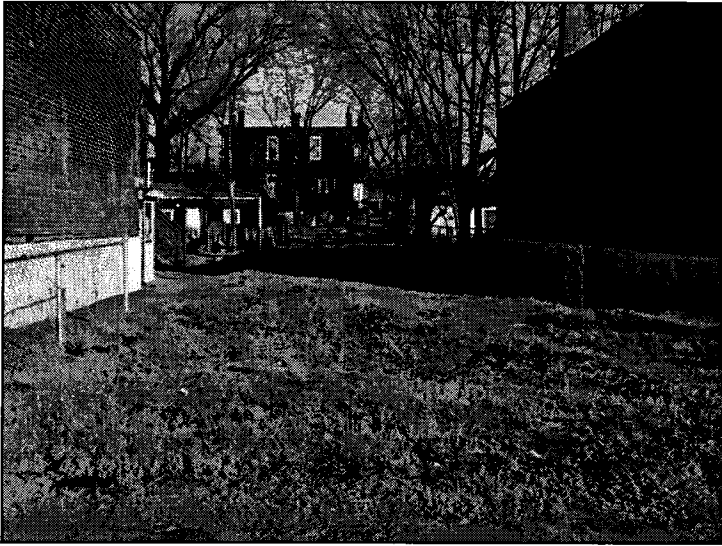
**Photograph 13**

4333 Hunt Avenue, view of sampling  
location 6. View is facing north from Hunt  
Avenue.

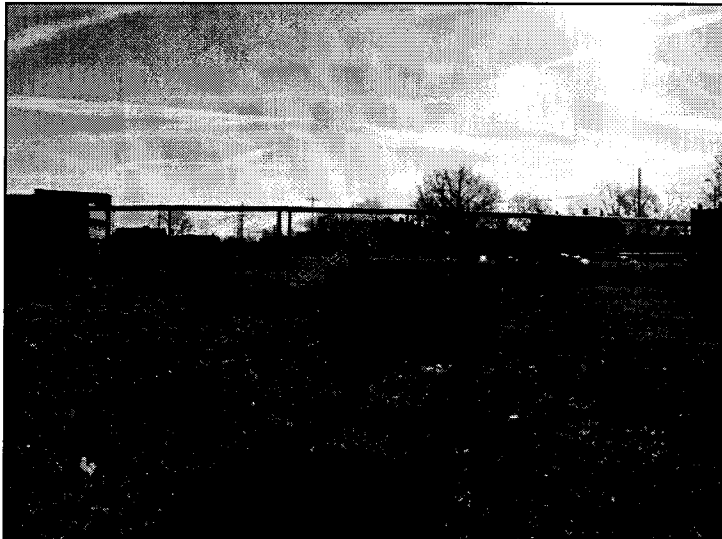
**Photograph 14**

Adams Park, view of sampling location 7.  
View is facing southeast from corner of  
Newstead Avenue and Norfolk Avenue.

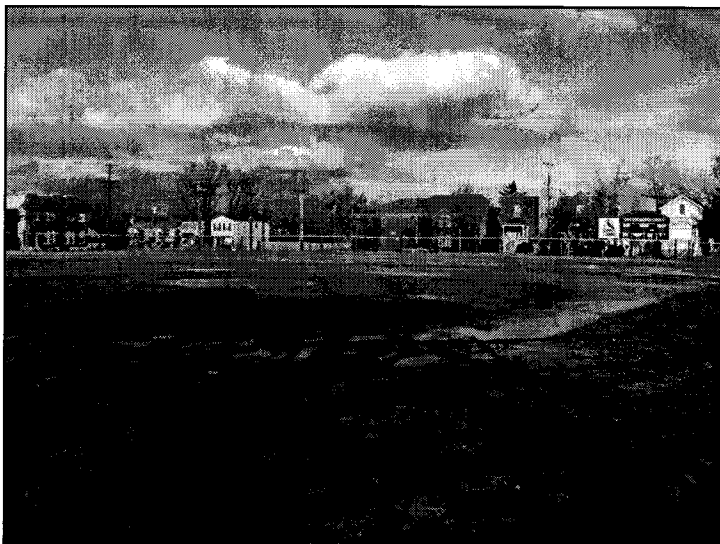
**Photograph 15**

Adams Park, view of sampling location 7.  
View is facing northwest from Vista  
Avenue.

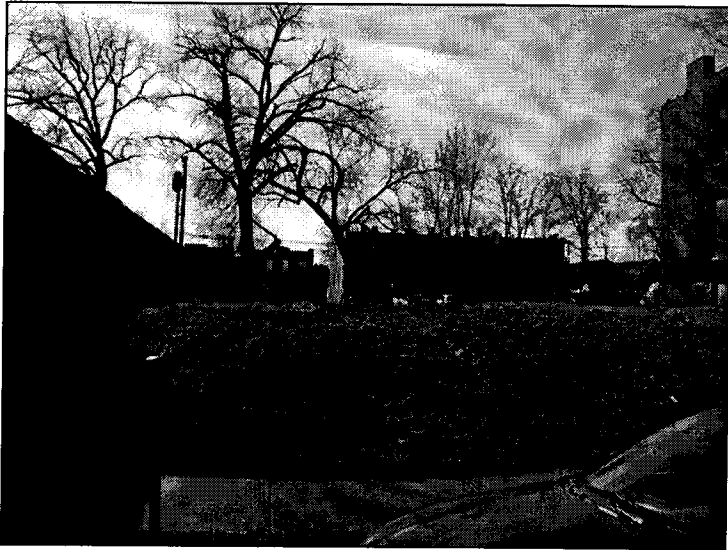
**Photograph 16**

4312 Manchester Avenue, view of sampling  
location 8. View is facing southeast from  
Manchester Avenue.

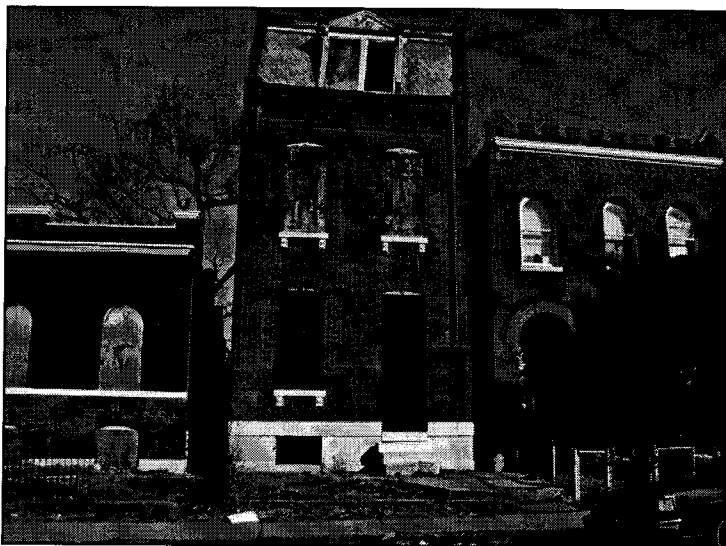
**Photograph 17**

4311 Gibson Avenue, view of sampling  
location 9. View is facing southeast from  
alley north of Gibson Avenue.

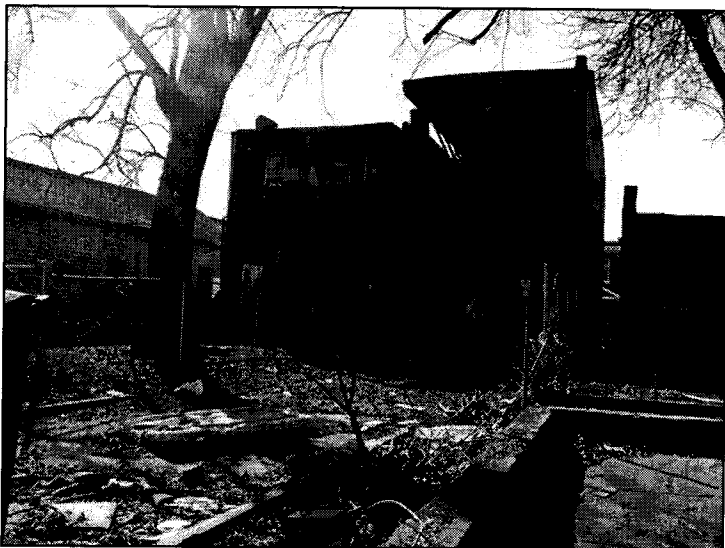
**Photograph 18**

4311 Gibson Avenue, view of sampling  
location 9. View is facing southeast from  
alley north of Gibson Avenue.
